Desktop Board CC820 Specification Update

Release Date: June 2000

Order Number: 749730-004

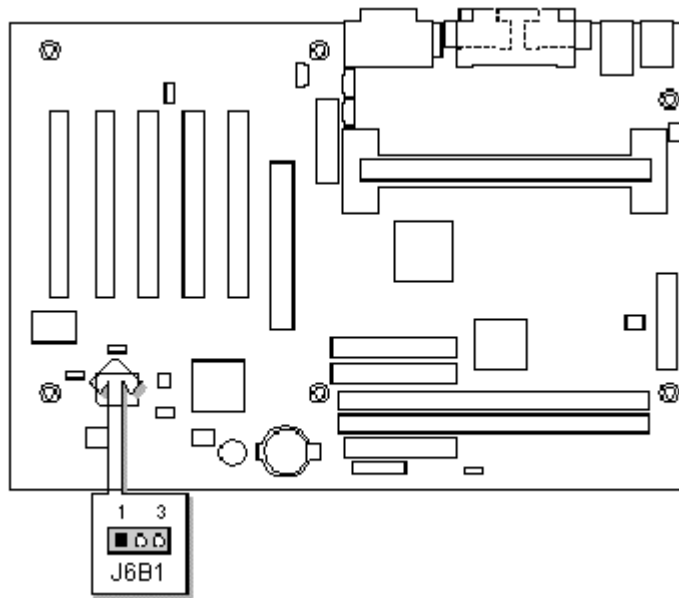
Figure 16. Location of the Jumper Block

The addition of jumper block J6B1 provides additional user control over system wake events. When the jumper is in its default location (shorting pins 1-2) the system will resume from S5 when a PME or WOL event is asserted. If the jumper is placed on pins 2-3 the system will no longer resume from S5 when PME or WOL events are asserted. This jumper does not in any way impact S3 resume events. *Please note that in order for the system to resume from S5 the operating system and drivers must also be configured to enable these wake events.*
